HISTORIC STRUCTURES REPORT  
SAN FRANCISCO CITY HALL

Prepared for  
CITY & COUNTY OF SAN FRANCISCO  
DEPARTMENT OF PUBLIC WORKS  
BUREAU OF ARCHITECTURE

July 12, 1993

CAREY & CO.  
ARCHITECTURE

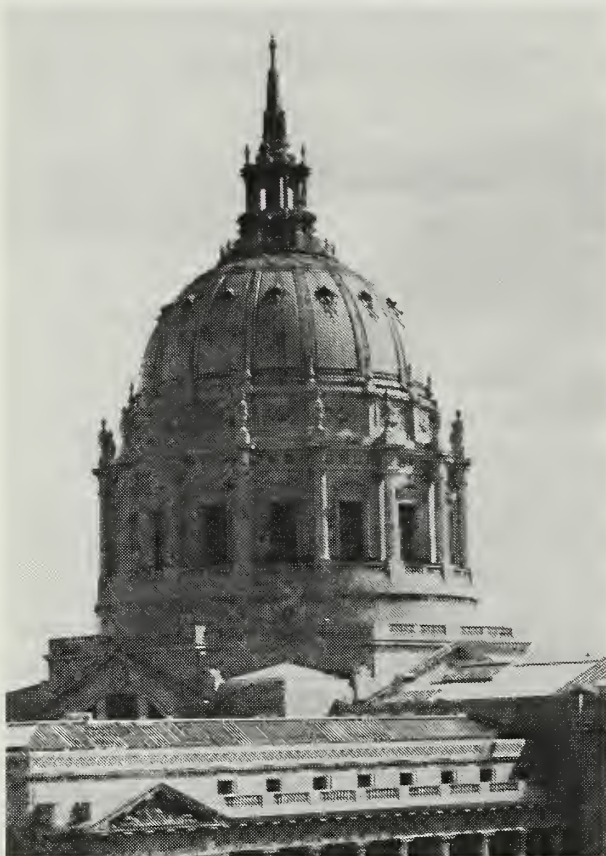
Figure 12 - Dome

The entire dome appears to be intact with minimal alterations. Structural reinforcement has been added at the octagonal drum base granite balustrade.

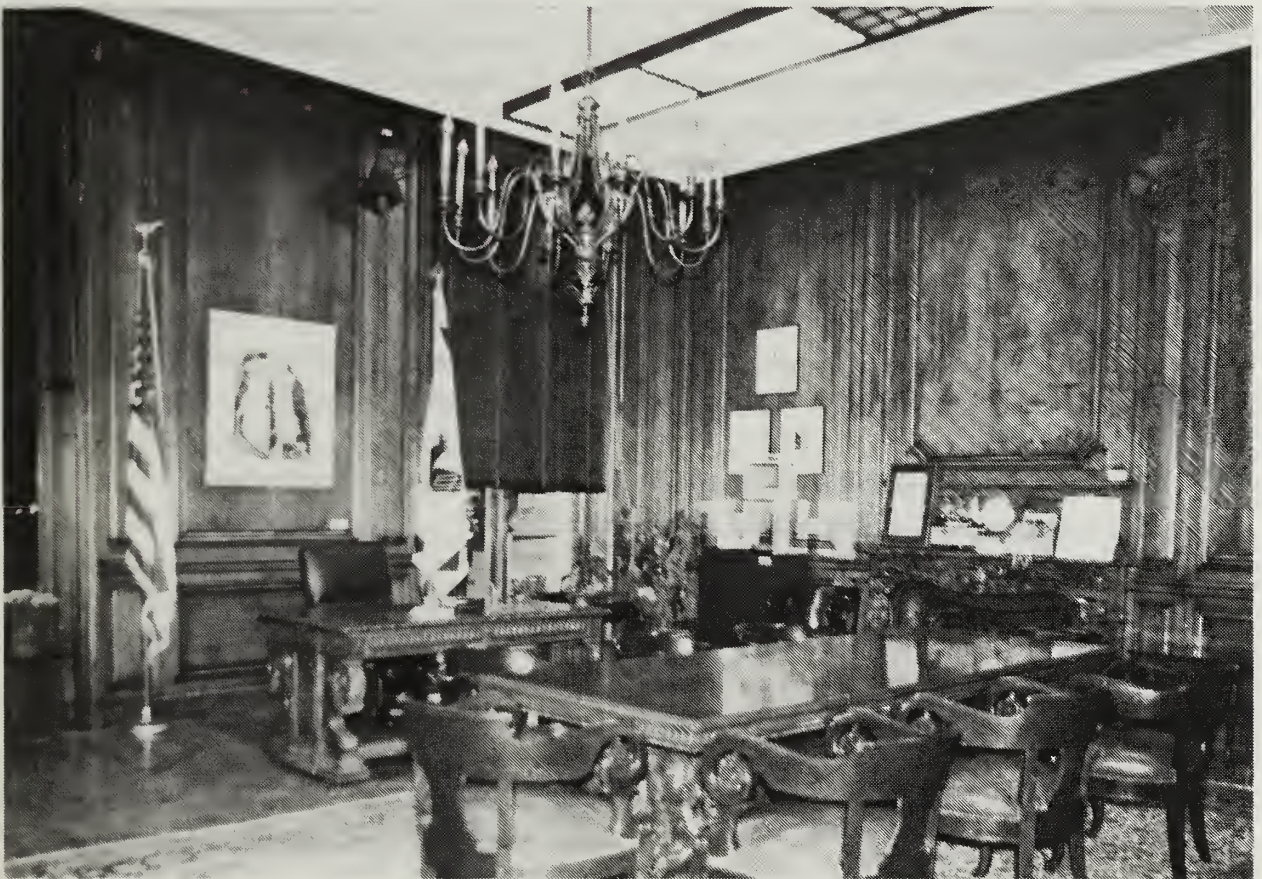
Figure 27 - Mayor's Office

These are the most significant rooms in the mayor's suite (see figure 27). They are largely intact with the exception of non-contributing lighting in Room D209.
